8XC196NT SPECIFICATION UPDATE

Release Date: January, 1999

Order Number: 272865-004

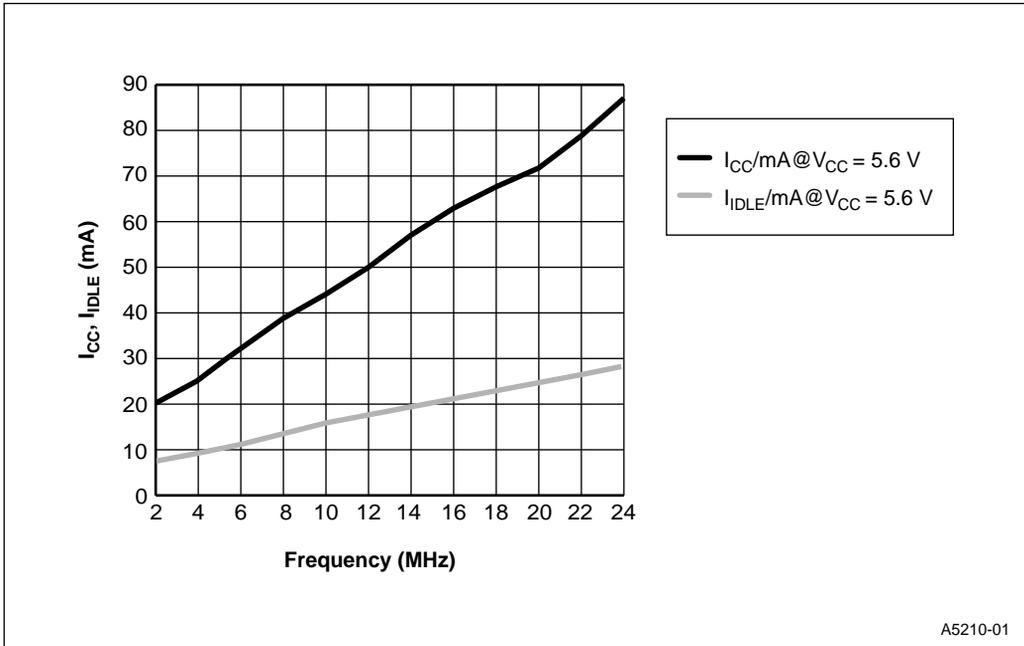
Figure 1. ICC, IDLE versus Frequency

ITEM: The following graphic illustrating ICC and IDLE versus Frequency will be added to the next revision (-005) of the 8XC196NT CHMOS Microcontroller datasheet.

001. *Added ICC, IDLE versus Frequency graph; will be added to revision -005 of the datasheet.*
